# Analysis of the bedding landslide due to the presence of the weak intercalated layer in the limestone

**Abstract** Analysis and research results show that the sliding plane of Jiudingshan landslide is along the weak intercalated layer (clay-filled) in the limestone and the sliding block is separated by the tension crack on the slope crest. The earlier study results show that for the rough, ups and downs structural plane, when  $i$  is greater than 2.0, the shear strength of the structural surface is intensely close to the strength of the filling. By the earlier theory, this failure must be through the clay filling. In this study, the failure is back-analyzed and the shear strength of the infilling is tested by the laboratory direct shear tests for which samples were retrieved in the field. The failure cannot be explained by the laboratory results of shear strength parameters. To simulate the field conditions, the real strength parameters of sliding surface are measured by the in situ shear tests for the weak intercalated layer. By the in situ tests, it is shown that the failure initiates along the contacts between the clay infilling and the limestone boundaries, but not through

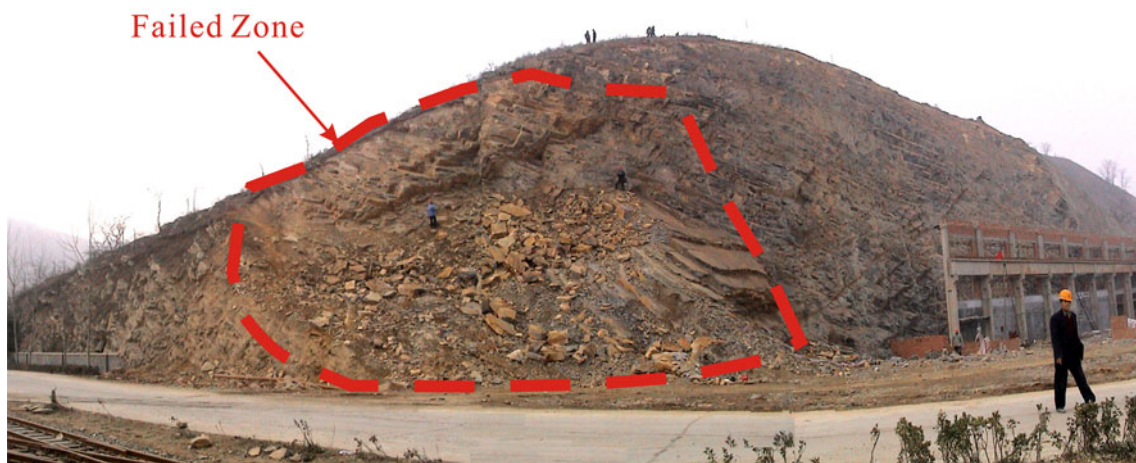
**Fig. 4** The failed slope showing tension crack at the head and sliding plane

Due to excavation, the rocks move slowly. During construction stage of the plants, a tension crack developed along the strike of joint sets 2, with width of 20 cm. A small-scale fast failure took place southeast of the slope. The instable block is about 10 m wide and 23 m high; the visible sliding plane length along sliding direction is more than 20 m. The failure consequently destroyed part of the new plants. By measurement for the landslide body, connecting the topographic contour map of the slope before

failure, the section crossing the failed rock masses (Section I–I indicated in Fig. 2b) could be precisely plotted. The site investigation reveals that the sliding plane is through a relatively weak intercalated layer (Fig. 2b, c), in which the main component is clay. The weak layer gets distributed along the bedding plane in the limestone. As a result of the failure, the tension crack develops a series of little cracks along joint sets 2 (Fig. 4).

In summary, the slope face dip is  $70^{\circ}$ – $80^{\circ}$  (Figs. 3, 4), with dipping direction of  $30^{\circ}$ – $45^{\circ}$ . The sliding plane is near the bedding stiff intercalated clay layer in the limestone and may be affected by the other joint set. The attitude of the clay is consistent with the limestone, white to gray, with thickness ranging between 0.1 and 0.3 m, in which the main mineral is montmorillonite, containing some calcium, with the unit weight,  $\gamma_d = 19.2 \text{ kN/m}^3$  (laboratory determined). The natural water content was 8–12 %, with the liquid limit (LL) 75–84 %, plastic limit (PL) 27–32 %. The permeability of the clay is poor.

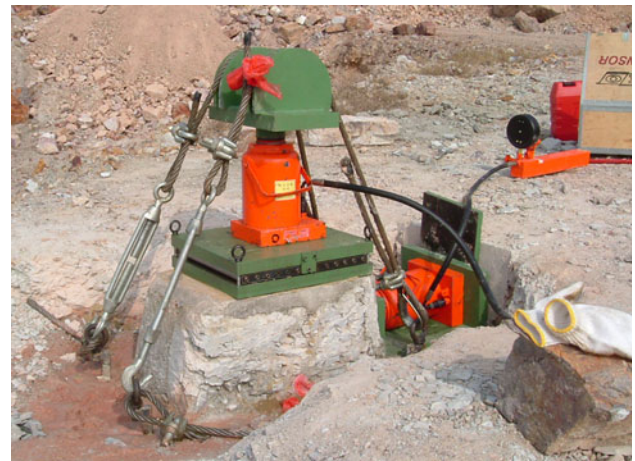
**Fig. 8** Equipment of shear test of clay–limestone contact

shear plane is 40 cm, and the shear planes are set in the weak intercalated layer. To prevent the rock above the contact from being damaged or great deformation, the upper rock was packed with cement mortar, thus, being made into a regular shape (Fig. 8). The top surfaces of the sample are all flat, and paralleling with the intercalated layer. The four sides are flat and vertical to preset shear surfaces. In test processes, the shear stresses and normal stresses acted on the shear surfaces are loaded by hydraulic jacks. At the four corners, the 6 m long resin anchors were preset before tests as the anti-power of normal loading. The four dial gauge are preset (two for monitoring the vertical displacements, the other two for monitoring shear displacements), the arithmetic mean values are calculated by the monitored results of both groups. The steel boards were laid between the samples and the jacks, which can guarantee that the stress on the contact is uniform. There are two steel boards under the normal jack; the rollers were laid between the two boards for adapting to the shear deformation.

Before starting normal loading, the steel board, rollers, the other steel board, hydraulic jack, columns for transferring load and the anti-power equipments were laid in turn. As well as the shear loading, the similar components were laid in turn. After installation, the jacks were initiated to load a small amount and make the system combine closely.
